Evaluation and Performance Analysis of Liquefied Petroleum Gas Cylinders

This paper presents the experimental results of the tensile, bending, hardness, hydrostatic testing, and microstructural properties of liquefied petroleum gas cylinders from local sources. The burst pressure and fracture sites were also investigated. In addition, know how LPG cylinders are compliant with ISO 4706 requirements as per standard to get approval and acceptance. The tests were performed on three samples (C1, C2, and C3), and all the tests were according to the specification. Tensile testing was carried out at room temperature (23°C) as per ISO 6892-2016. Tensile test specimens with a gauge length of 50 mm were prepared from the sidewall of cylinders. The equipment used is built up around a 250 KN maximum capacity of (Instron Servo-Hydraulic Testing Machine Model 1332). At the same time, micro-hardness testing was carried out as per ASTM A384. Diamond indenter (pyramid) with a face angle of 136° was used. During testing (1kg) load was applied on the sample with a dwell time of 15 seconds. As for bending tests were carried out in accordance with ISO 7438 for all cylinders to evaluate their welding qu

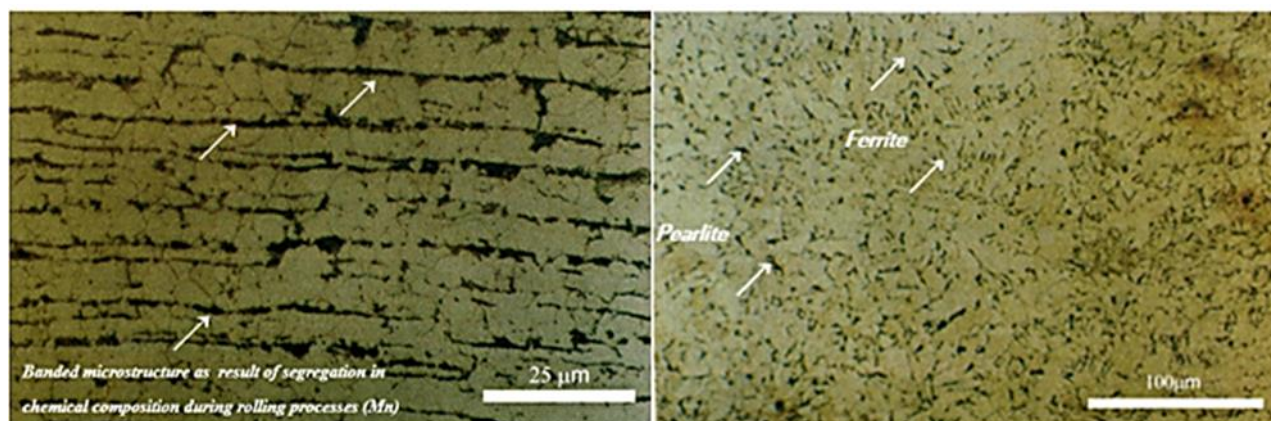
Fig. 3. O.M. image of LPG Cylinder. The Right Shows a Ferrite and Pearlite Structure. Left Shows a Longitudinal Banded Structure Extending in the Rolling Direction

First, we should mention that the goal to link microstructure examination in the current study was for the purpose of ensuring the results obtained by chemical analysis are fits with obtained microstructures examination. And this point has been confirmed. Furthermore, general characteristics of the microstructure were observed under the optical microscope from cylinder samples in the longitudinal direction (the rolling direction). The specimen was ground, polished following standard procedure, and then etched by 2% Nital solution. Examination under the optical microscope was carried out at various magnifications. Microstructure showed that the structure consists of ferrite and pearlite with equiaxed grains as shown in Fig. 3 (R – side) and indicated by the arrow, the ferrite phases are the light patches, whereas the pearlite phases are the black to grey patches comprising of alternating layers of ferrites and cementite (consists of fine lamellar structure).

The presence of the uniform and equiaxed shape grains indicates that the cylinders have undergone a subsequent heat treatment process (treatment after the completion of all manufacturing processes) for the purpose of freeing them from residue stresses and also an indication that the recrystallization process was successfully completed, which leads to improving compatibility between strength and ductility. This means expecting the cylinders to pass the tensile test (as a measure of strength) and bending test (as a measure of ductility) with success. Moreover, it will give us: to improve their resistance to the formation of cracks. Non-fragmentation of cylinders when collapse or failure occurs. Also, this is enhanced by the presence of a sufficient amount of manganese $\sim 0.45\% \sim 0.47\%$ as shown in the sections following. In addition, is one of the requirements of ISO 4706. While at the mid-thickness of the cylinder structure, a banded structure will exist. The reason it exists is due to the segregation of the alloying elements during solidification. Subsequent hot-working operations result in segregation aligned in the direction of working processes, which results in the banded appearance delineated in the microstructure as shown in Fig. 3 (L – side). Its presence was limited to a few bands only, which means that it does not affect the results.
