Post Weld Heat Treatment Qualification of Type 304L Stainless Steel Weld Metal

Abdulnaser Hamza Fadel

Al Zawia University, Faculty of Natural Resources

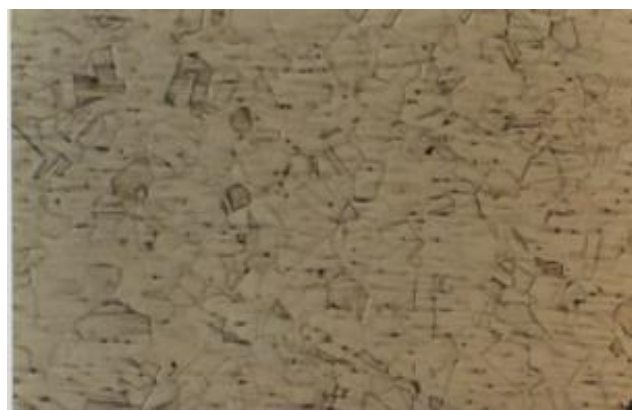
Fig. 1 Microstructure of the base metal as-received after streicher testing – 200X.

The microstructure of the as-received base metal obtained after streicher screening corrosion test (electro etching in 10% oxalic acid) is introduced in Fig.1. below

showing no signs of carbide precipitation at high angle grain boundaries could be observed indicating no sensitization. However Fig.2 introduces the microstructure of the same specimen but subjected to sensitizing annealing at 650°C for 60 min. Some isolated precipitates are observed at high angle boundaries. Such type of dual microstructure is acceptable for 304L stainless steel. The average grain size generated of the base metal was determined using a linear intercept technique is found to be 20µm.

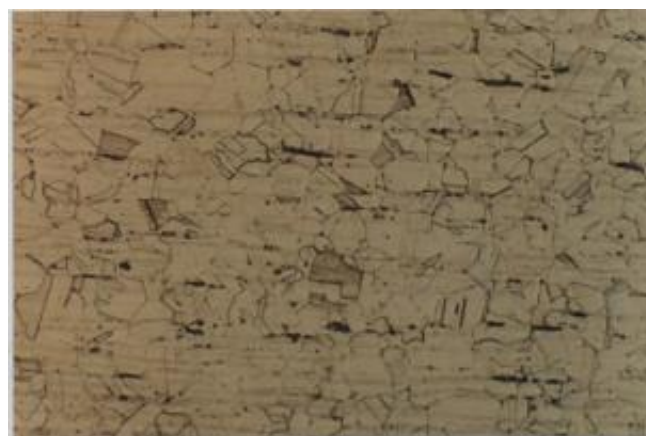
Fig. 2 Microstructure of the base metal after sensitization annealing and streicher test – 200X.

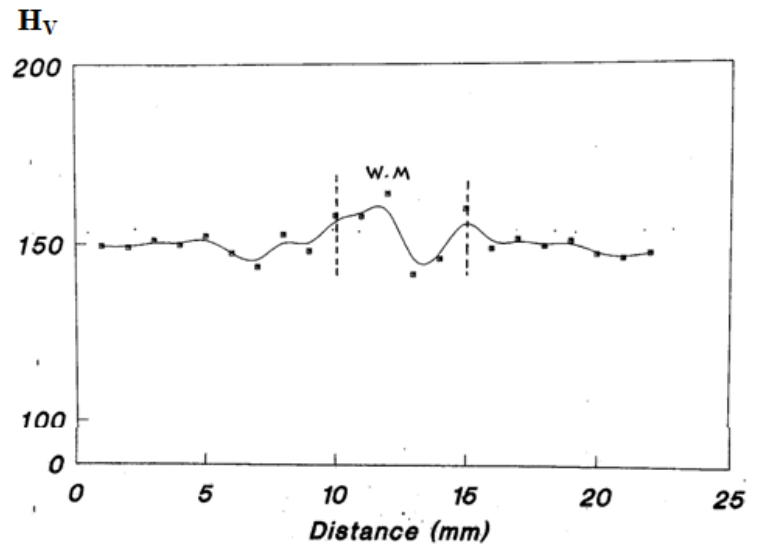
Fig. 3. Showing the hardness traverse the weld bead.

For each specimen, the Vickers hardness was measured using a 1 Kg/mm² as indentation load. The hardness measurement was carried-out at five points in the region of specimen where microstructure observation was made. However, after the microhardness test, the hardness traverse across the weldment (Fig.3) didn't show any systematic hardening effect in the HAZ indicating no sensitization effects.

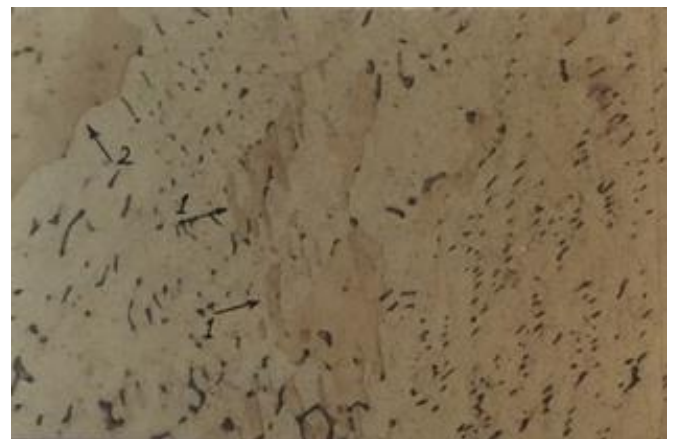
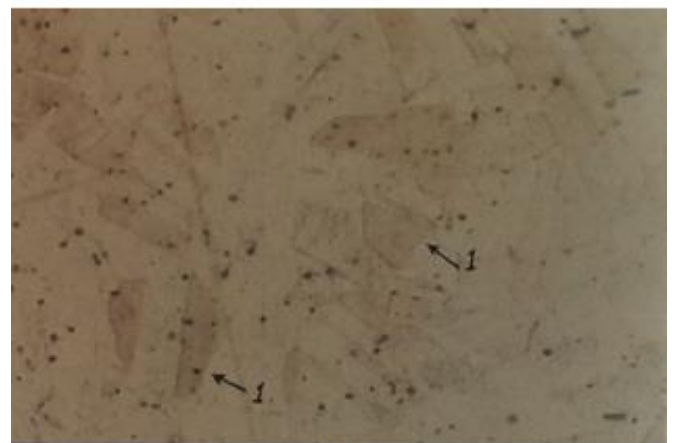
Fig. 4 (a , b) Microstructure of the base weld metal as received in two different positions (etched in 10ml HNO₃, 10 ml acetic acid, 15ml HCL, and 2 drops glycerol) – 400X

The microstructure of the weld metal (Fig.4) indicates several recrystallized small grains with characteristic annealing twin boundaries as marked (a) on the figure 4. Occasionally same interdendritic boundaries show signs of stress induced migration as marked (b) on the same figure. It can be concluded that the recrystallization processes have started in the weld metal of the as-received welded material.

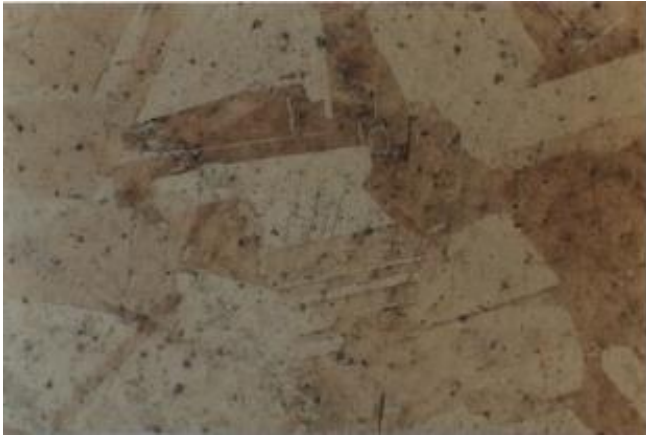
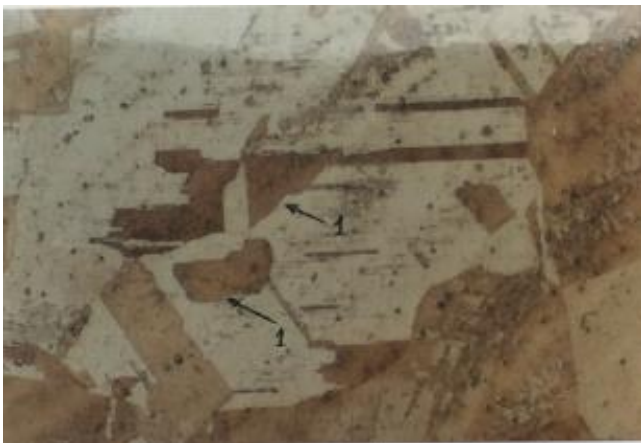
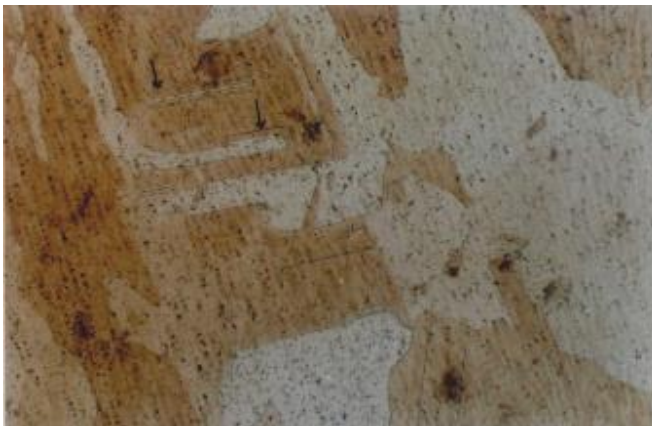
Fig. 5 (a, b and c) Microstructure of the weld metal after repeated solution treatment in three different positions (etched in 10ml HNO₃, 10 ml acetic acid, 15ml HCL, and 2 drops glycerol) – 400X.

Representative specimen were given additional solution treatment under the same regime as the claimed one. So the microstructure of the weld metal after repeated solution treatment (Fig. 5) revealed largely recrystallized structure, where small islands of the cast structure was retained. The average grain size of the material was observed to increase substantially during the treatment. Hardness traverser, however, did not show noticeable change. The δ -ferrie content of the weld metal decreased to 2.9 %.
